HIGHWAY RESEARCH REPORT

INVESTIGATE USE OF LIME FOR TREATING CLAY SOIL FOR USE AS A BASE UNDER ASPHALT CONCRETE SURFACING

NO. M & R 633190

June 1967

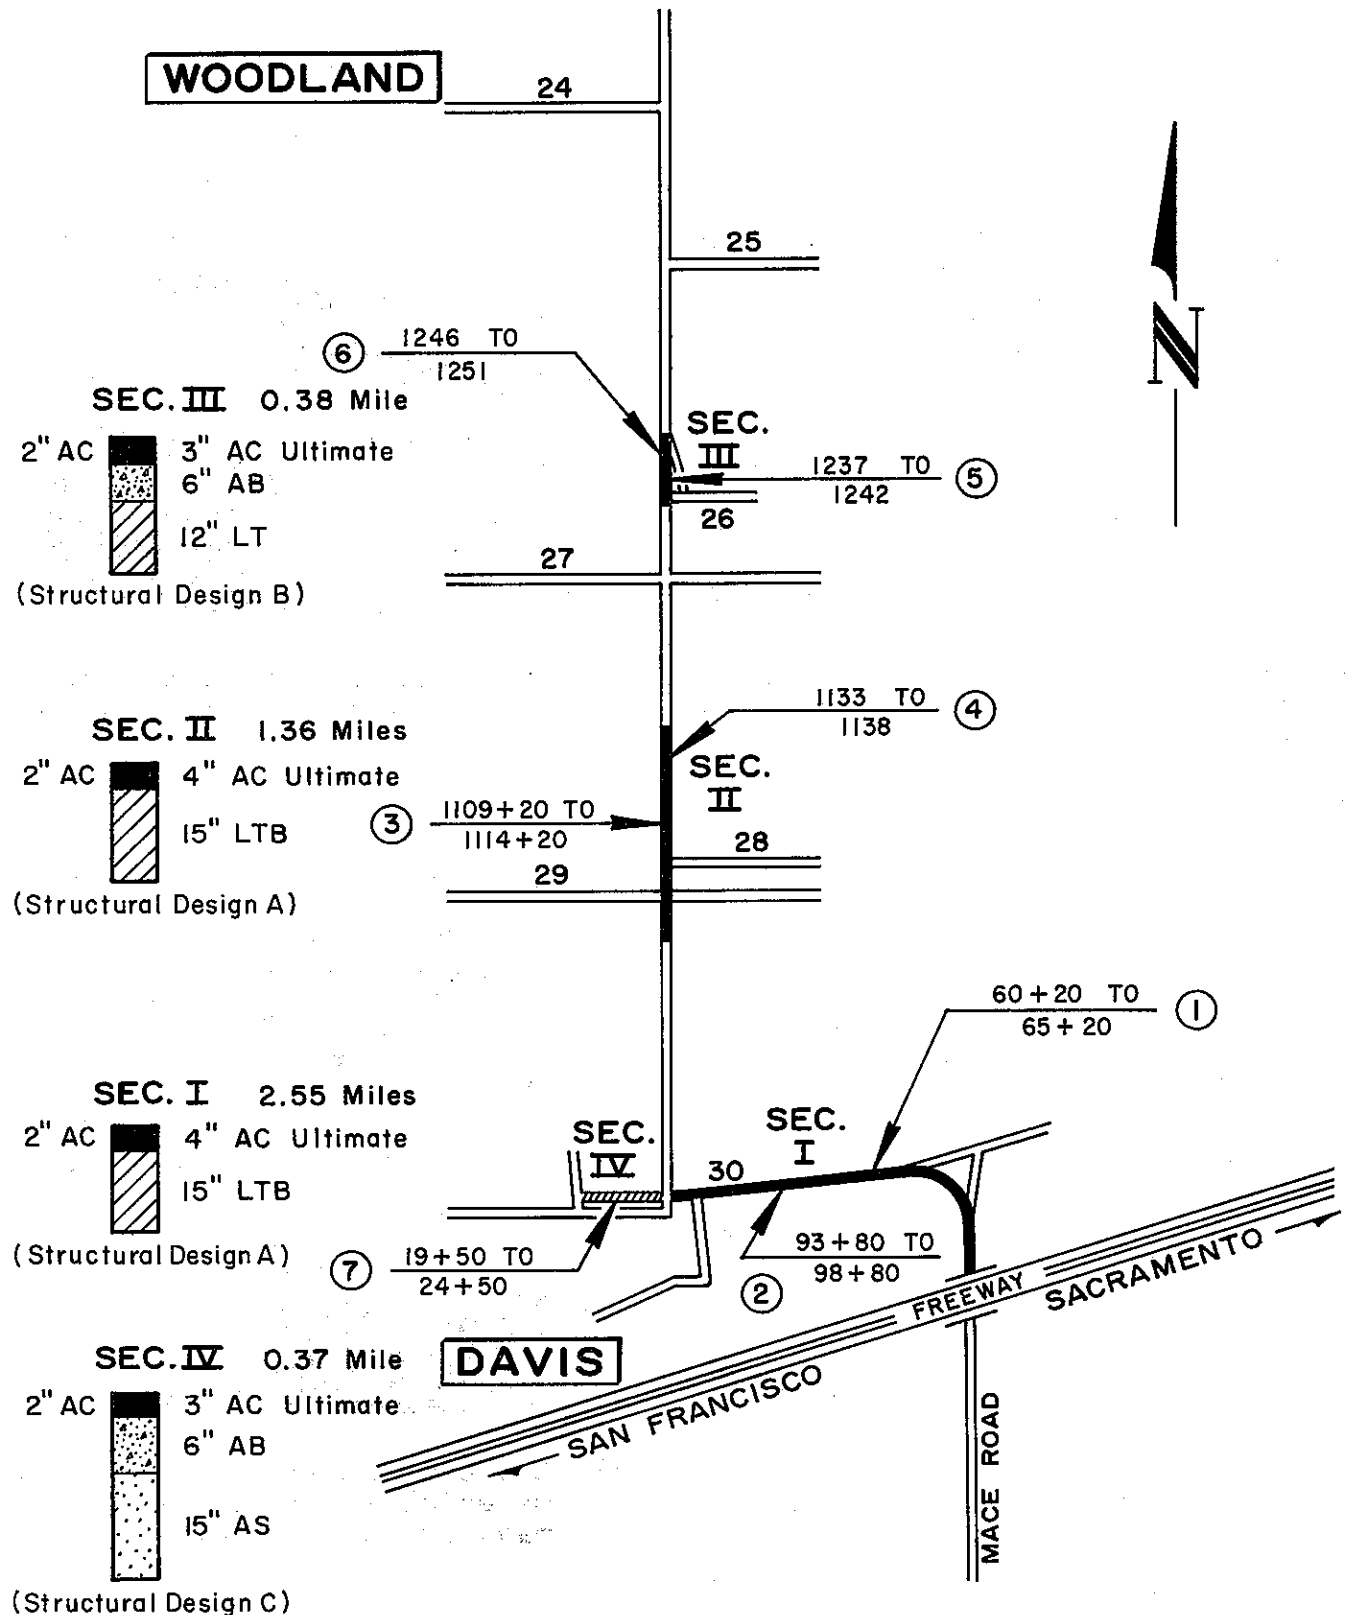
Figure 2

The lime treated material was placed in three 5-inch lifts. It was necessary to move material to one side of the road while mixing the first and second layers. About 0.15 gallon of SC-250 was used as a curing seal and prime coat on the top lift. Figures 2 and 3 illustrate some of the operations.

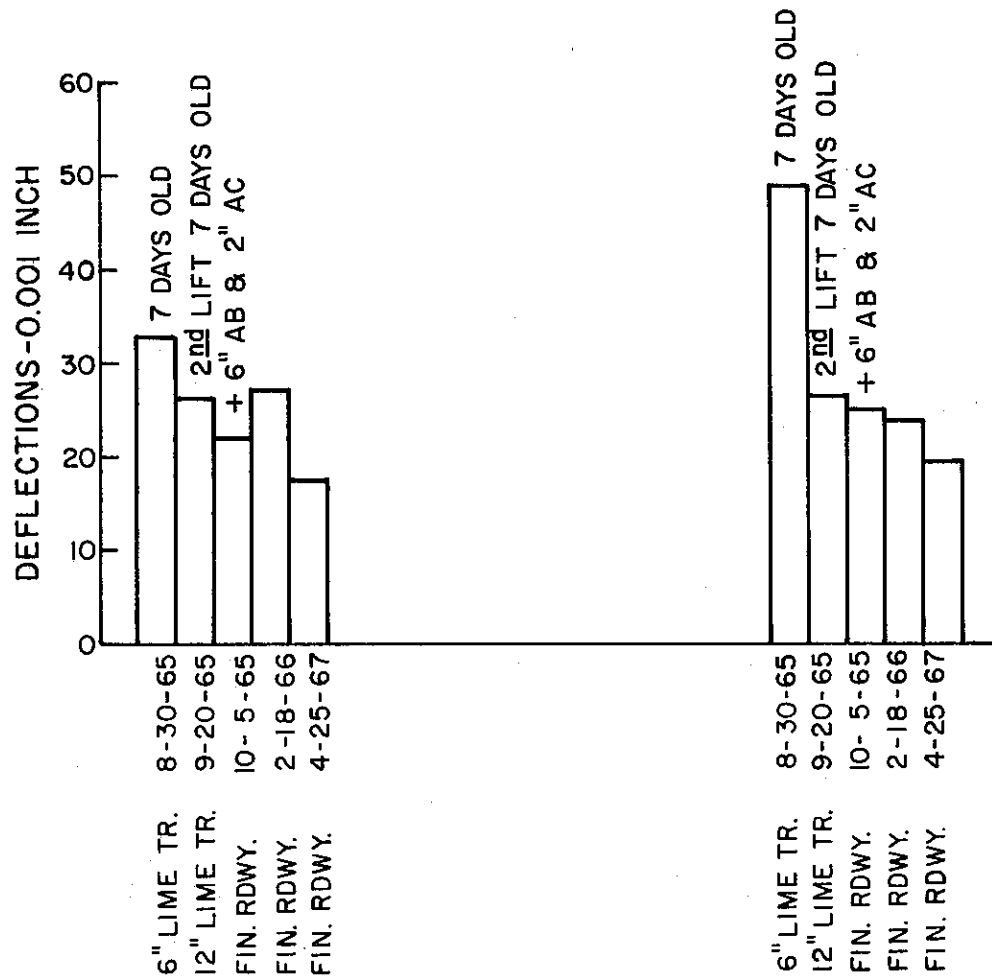
Figure 7A

This section of road was constructed on new alignment. Average deflection measurements on the inner and outer wheel tracks are shown for the LTS-AB sections 5 and 6, on Figures 7 and 7A. Average deflections ranged from 0.029" to 0.049" on the first 6 inches of lime treated soil after 7 days of compacted curing time. Average deflections ranged from 0.026" to 0.031" after the second 6-inch layer of lime treatment and 0.022" to 0.025" after the 6-inch layer of untreated aggregate base and 2 inches of asphalt concrete surfacing were placed.

AVERAGE DEFLECTIONS ON ROAD 3-YOL-1196

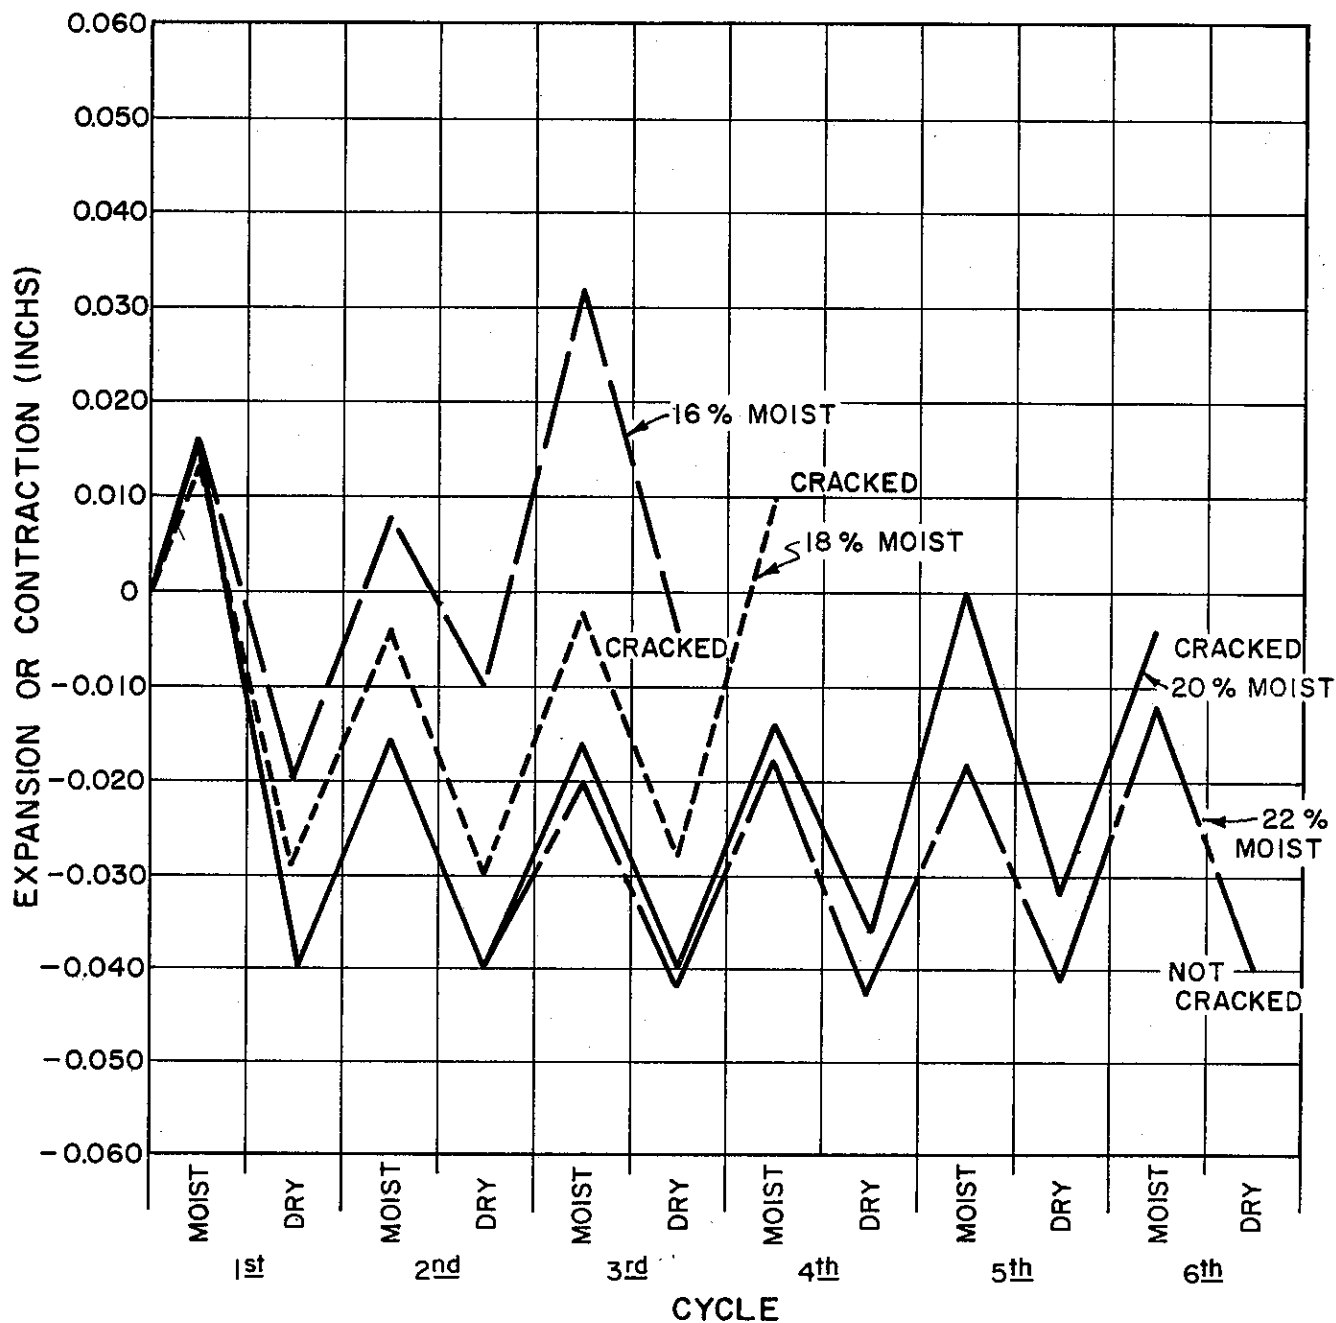
Figure 11

Some cracking occurred in the lime treated layers after mixing and compacting. In order to evaluate this problem, some laboratory tests were performed. Test bars were fabricated with varying amounts of water and varying curing time. The laboratory data indicated that expansion and shrinkage of the clay soils were not completely eliminated by lime treatment.

EXPANSION AND CONTRACTION OF LIME TREATED BARS

4% LIME
28 DAY COMPACTED
CURE BEFORE TEST
3"x3"x11.25" TEST SPECIMEN

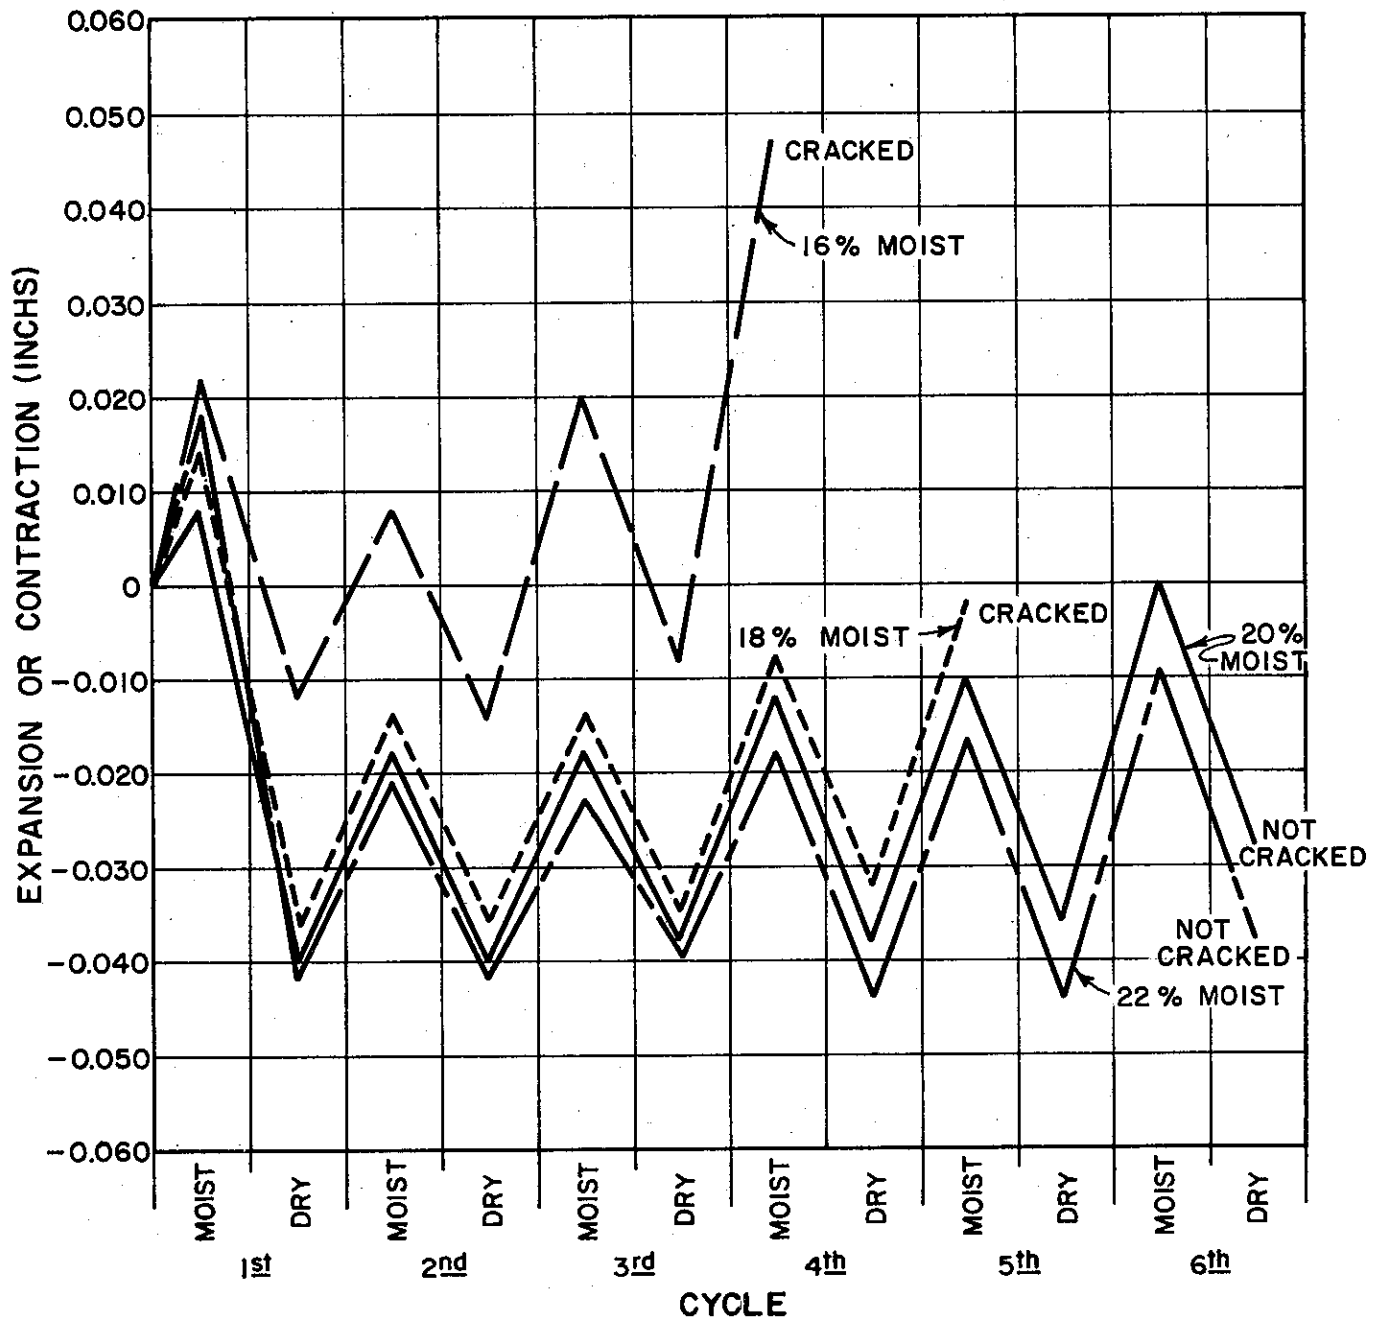
Figure 13

5. Laboratory tests on lime treated soils from this project indicated a moisture content over optimum and loose curing periods under 24 hours tended to minimize cracking caused by contraction and expansion.

EXPANSION AND CONTRACTION OF LIME TREATED BARS

4% LIME
24 HOUR LOOSE CURE &
7 DAY COMPACTED CURE
BEFORE TEST
3"x3"x11.25" TEST SPECIMEN
